F. No. 12-12/WCCB/2023/Part 1313

Sub: Constitution of the Committee to inspect the recent death of Elephants in the State of Jharkhand due to electrocution:-reg.

Enquiry Report on Elephant Electrocutation Incidences in East Singhbhum and Giridih Districts of Jharkhand During November 2023

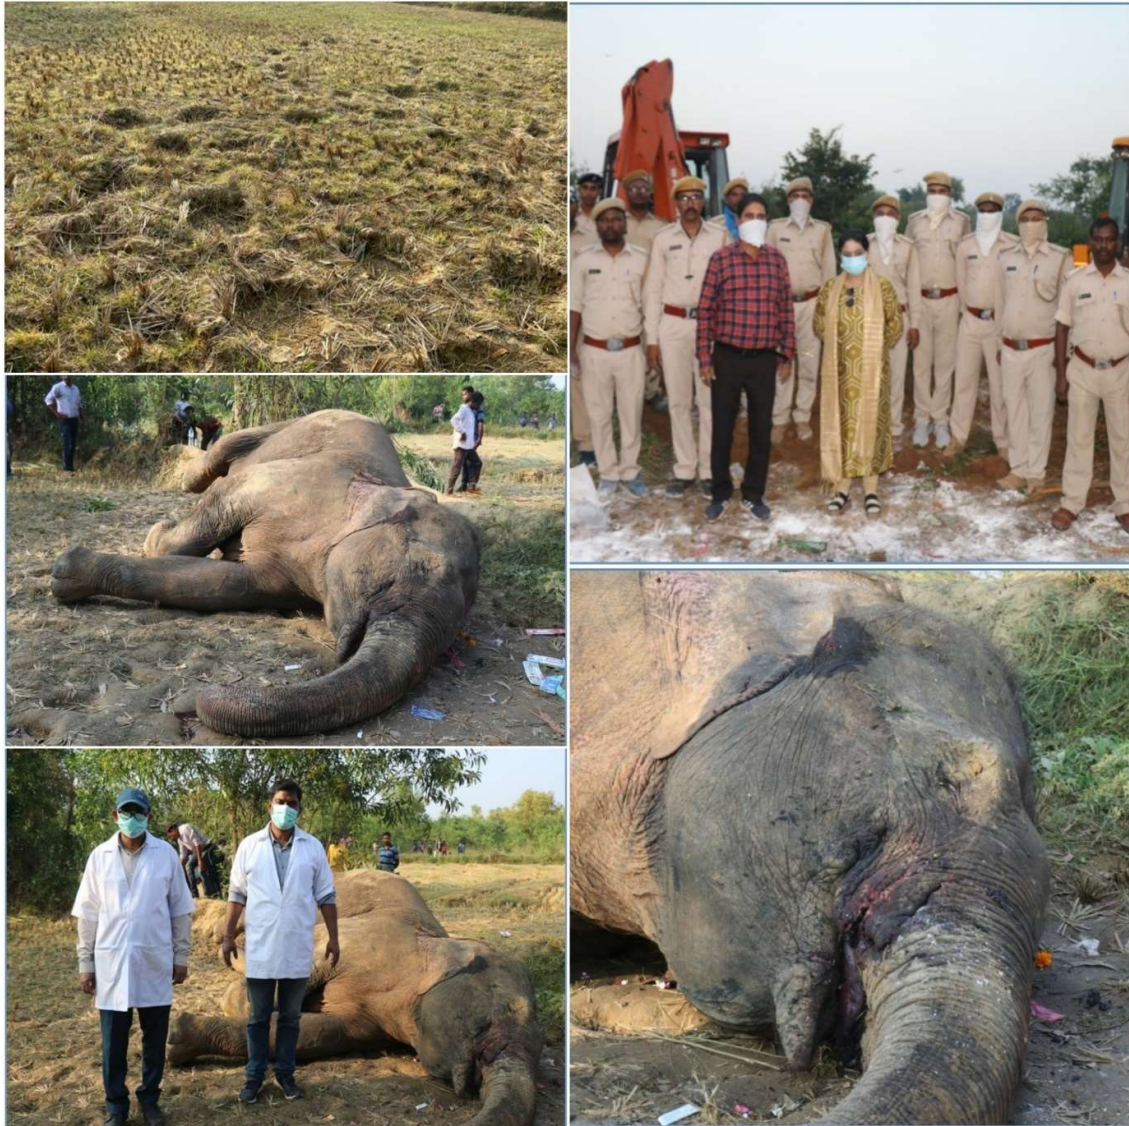
Photographs of Incident -1

- On 30/10/2023, a herd of 12 elephants ranging in Sonahara village received an electric shock from a low-hanging 11 KV power transmission line. The pole carrying the transmission line was located on the embankment of the pond. A few elephants received electric shock. After receiving the shock, the herd of elephants moved away from the site into the nearby forests.
- On 1/11/2023, the Forest Department staff received information that a cow elephant lying dead in the paddy field. The paddy field was in the ready-to-harvest stage.

- The Committee visited the both the site where elephants reportedly received electric shock from the 11 KV transmission line and also the site where the carcass was found and subsequently, postmortem was carried out. In the site where the dead elephant was found, the paddy has been wholly harvested. After postmortem, the elephant has been buried in the site.

- The aerial distance between the location of receiving electric shock and subsequent death of the elephant was 4.5 km
- The Committee spoke to several local villagers who came to the site during the inspection.

- The photographs of the deceased elephant taken before the postmortem were also examined (Enclosure – II).
- It is seen in past that Elephants, upon electrocution, die instantly and mostly in the same location. However, this was not the case.

- Dr. Rajesh Kumar Singh, Touring Veterinary Officer, who was enquired later at Jamshedpur mentioned that during the postmortem, the vitals such as the heart and genitals showed signs of electrocution. He further mentioned that the external injuries seen before conducting postmortem also indicated that the animal had received an electric shock. He also told that the circumstantial evidences including that of eyewitnesses from the village who saw elephants receiving the electric shock indicated that the animal died due to electric shock received on 30/10/2023.

On 01.11.2023 Poornapani village, Chakulia block, East Sighbhum District, Chakulia Forest Range, Jamshedpur Forest Division death of one elephant

2. The sagging 11 KV power transmission line in Sonahara and Surda village has been repaired.

- During the visit of the Committee, the sagging 11 KV wire was already found rectified.

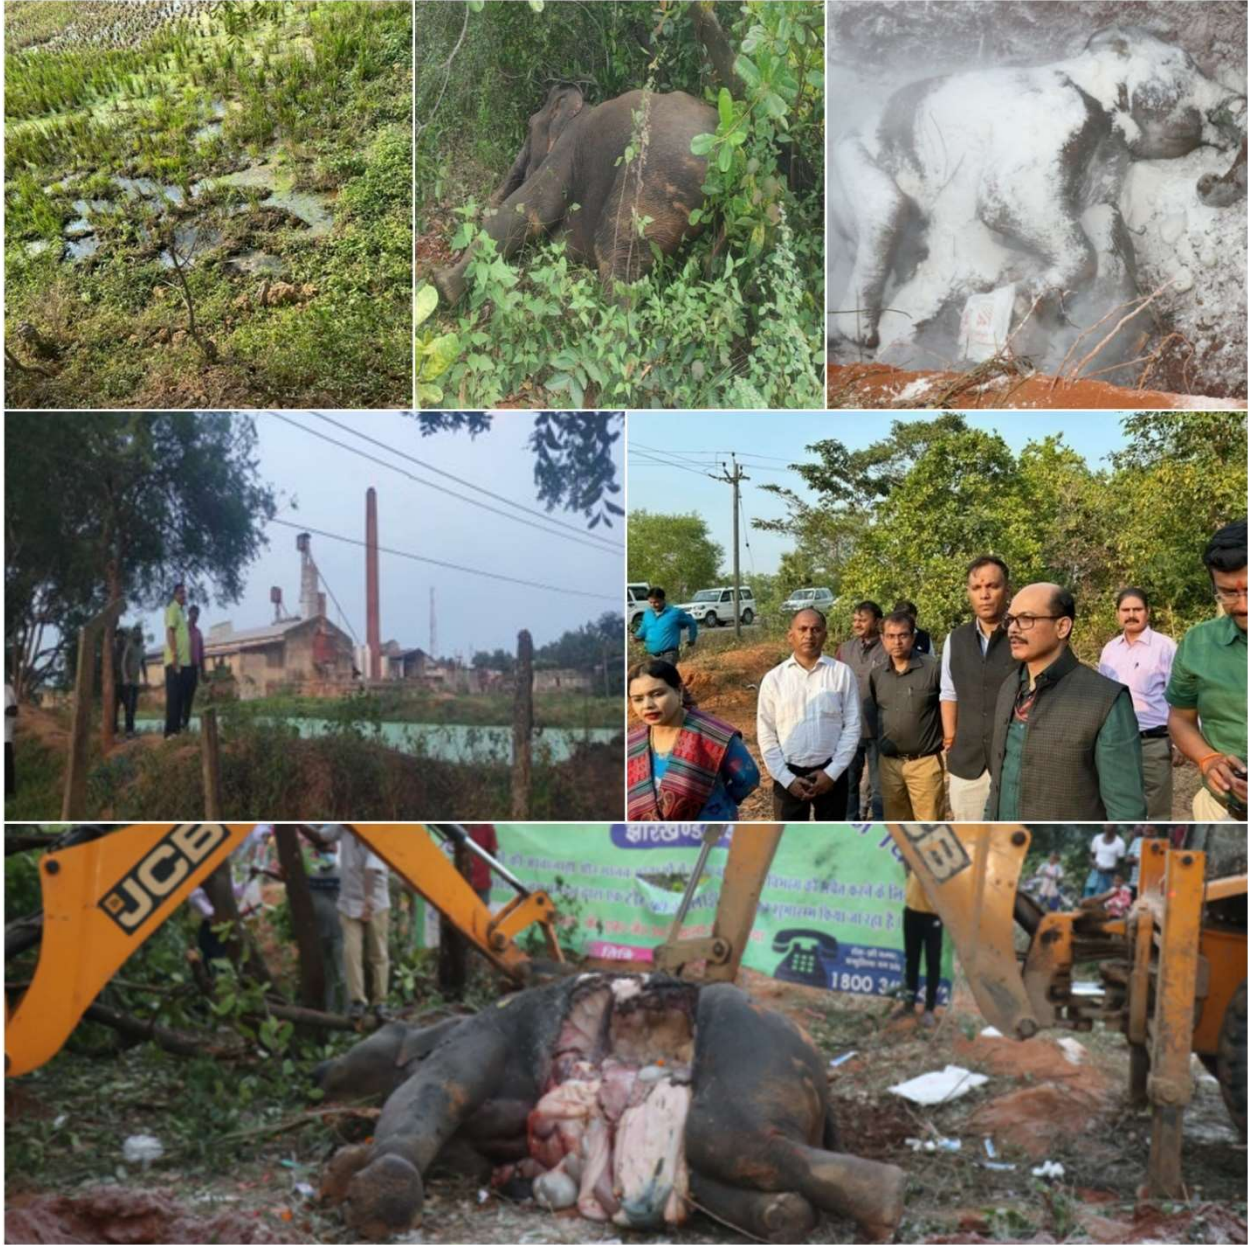
Photographs of Incident -2

- On 30/10/2023, a herd of 12 elephants ranging in Sonahara village received an electric shock from a low-hanging 11 KV power transmission line. The pole carrying the transmission line was located on the embankment of the pond. A few elephants received electric shock. After receiving the shock, the herd of elephants moved away from the site into the nearby forests.

- On 02/11/2023, the Forest Department staff received information that a cow elephant that appeared weak and had difficulty in walking near by forest area.

- The elephant tried to cross the CPT (cattle-proof trench) near the village road to get into the forest. However, based on eyewitnesses, the animal got down into the CPT, but couldn't climb over. It walked in the trench for about 20 meters and remained there. The villagers even tried providing water to the elephant (picture enclosed). The elephant did not recover. Eventually, it succumbed to death near the CPT.

- The Committee visited the both the site where elephants reportedly received electric shock from the 11 KV transmission line and also the site where the carcass was recorded and subsequently, postmortem was carried out.
- The aerial distance between the location of receiving electric shock and subsequent death of the elephant was 5 km
- The pictures of the deceased elephant taken before the postmortem were also examined (Enclosure - III).

- It is seen in past that Elephants, upon electrocution, die instantly and mostly in the same location. However, this was not the case.
- Dr. Rajesh Kumar Singh, Touring Veterinary Officer, Barhagora whom we enquired later at Jamshedpur mentioned that during the postmortem, the vitals such as the heart showed signs of electrocution. He further mentioned that the external injuries seen before conducting postmortem also indicated that the animal had received an electric shock. Furthermore, the circumstantial evidences including that of eyewitnesses from Sonahara village chakulia ward no. 9 that saw elephants receiving the electric shock indicated that the animal died due to electric shock received on 30/10/2023.

On 02/11/2023 electricution leading to the death of an elephant at Machadiha village, Chakulia block, East Sighbhum District, Chakulia Forest Range, Jamshedpur Forest Division

1. The committee was informed that in 22 out of 67 locations, the sagging wires have been rectified and along with the Range Forest.
2. The sagging 11 KV power transmission line in the village has been repaired.

- During the visit of the Committee, the sagging 11 KV wire was already found rectified.

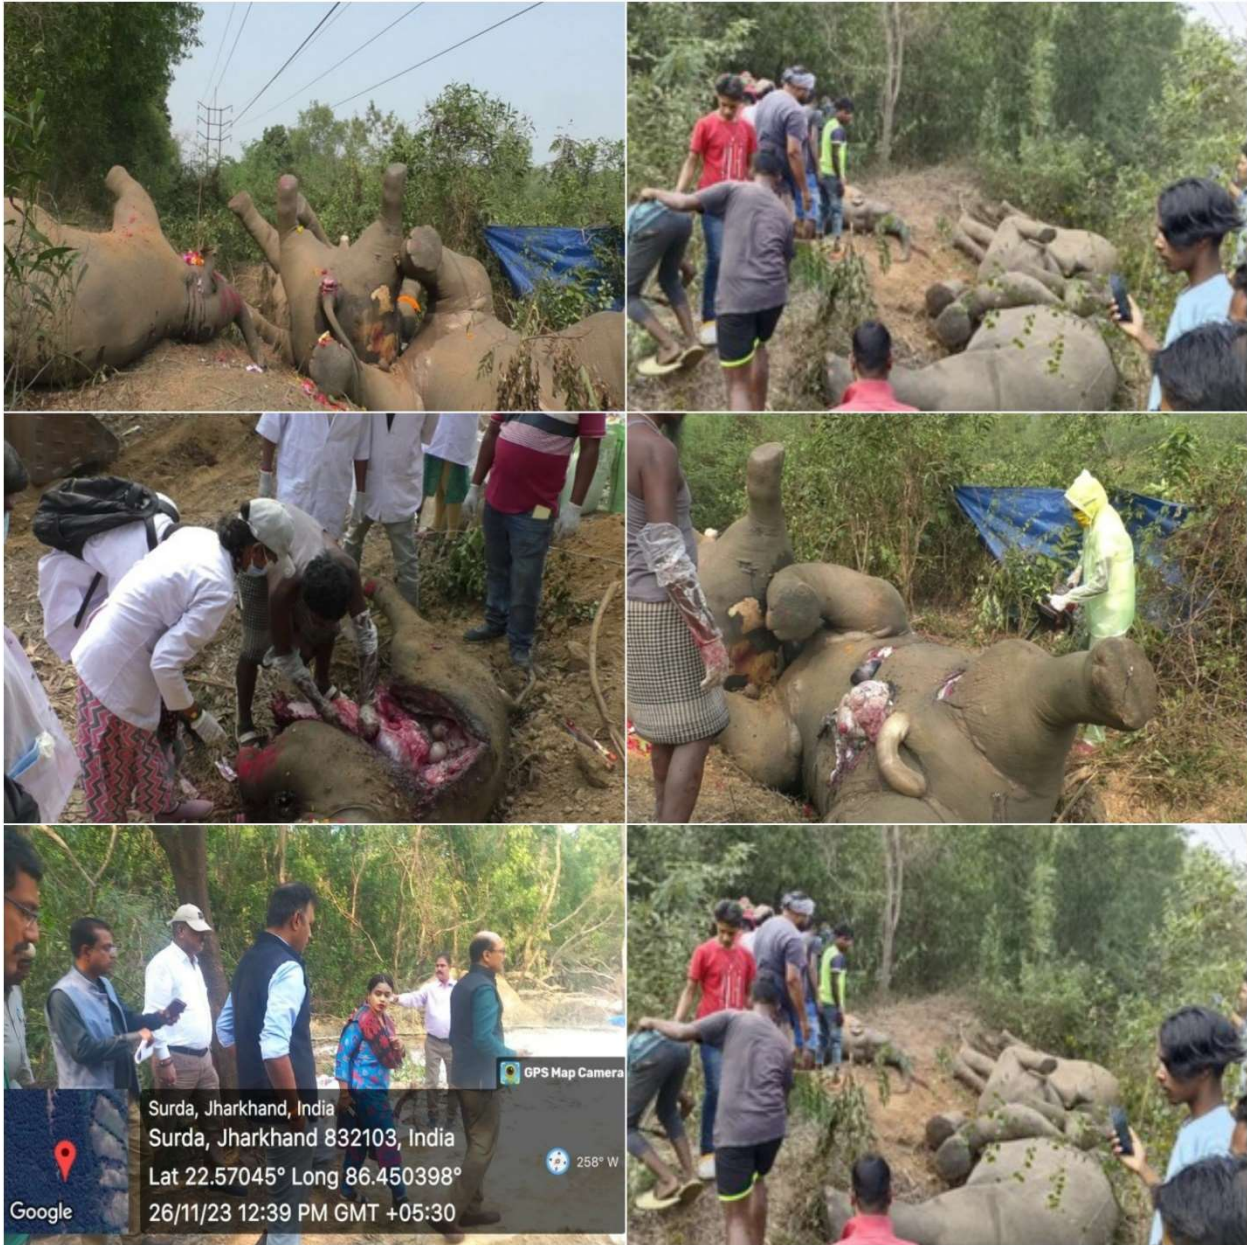
Photographs of Incident -3

- On 21/11/2023, a herd of 9 elephants crossed the Subarnarekha River and came to Upperbanda forest patch near Upperbandha village.
- On the night of 21/11/2023, the elephants came into contact with a 33 KV power transmission line.
- Five out of nine elephants died on the spot.
- Acting up on the information by the villagers post noon, on 22/11/2023, the Forest Officials reached the site at 3:00 PM, and found five dead elephants lying together underneath the 33 KV transmission line.

Engineer, Musabani.
<p>Action taken by Power Department:</p> <p>1. In the 33 KV line, the conductor that caused electrocution of elephants, the power supply was disconnected.</p>
<p>Observations and deliberations by the committee:</p> <ul style="list-style-type: none"> • Numerous eyewitnesses from the village were present during the inspection by the committee. One of the high witnesses from Upparandha Shri. Kumar Jitesh mentioned that sagging in the line was reported several times in the past as well. However, the sagging issue was not addressed at all resulting in the electrocution. • The villagers further mentioned that elephants have been sporadically using this Upparandha area for many decades. Annually, about 10-15 elephants use this area • One of the villagers mentioned that around 8:00 PM on 21/11/2023, elephants vocalized frantically and villagers saw blaze of fire following which there was a power shutdown. On the following morning, the villagers went to the site at around 12:00 noon and saw the dead elephants. The Forest Staff reached the site at around 3:00 pm and found 5 dead elephants. • The pictures of the deceased elephant taken before the postmortem were also examined (Enclosure – IV) • The conductor that caused electrocution of elephants was sagging at a low height of 8-9 feet from the ground. The conductor had charred tissues of elephants sticking to it • In this case, it is very much evident that the low sagging wire was the cause of electrocution. The conductor was sagging at 8 – 9 feet from the ground. It may be noted that the average height of adult elephants is around 8 to 9.5 feet. Large bulls can attain 10 feet height and in exceptional cases even about 11 feet. • Since elephants occur as a family unit and were possibly moving together during the incident, 5 out of 9 elephants in the herd were electrocuted in this single incident.

On 21.11.2023 electricution by 33 KV line leading to death of 05 elephants at Upperbandha village, Musabani block, East Singhbhum District, Musabani Forest Range, Jamshedpur Forest Division

- II. During the enquiry, of incident 3, criminal negligence of the Hindustan Copper Limited has been reflected. Hence a criminal action could be initiated on priority.

- a. 33 KV line belonging HCL shall be immediately repaired to remove sagging and raise the pole height. The lower 2 conductors of the alignment are to be removed with immediate effect and shifted to the top of the double-pole structure. In the second phase, while modifying the existing alignment, insulated conductors should be used instead of naked conductors.

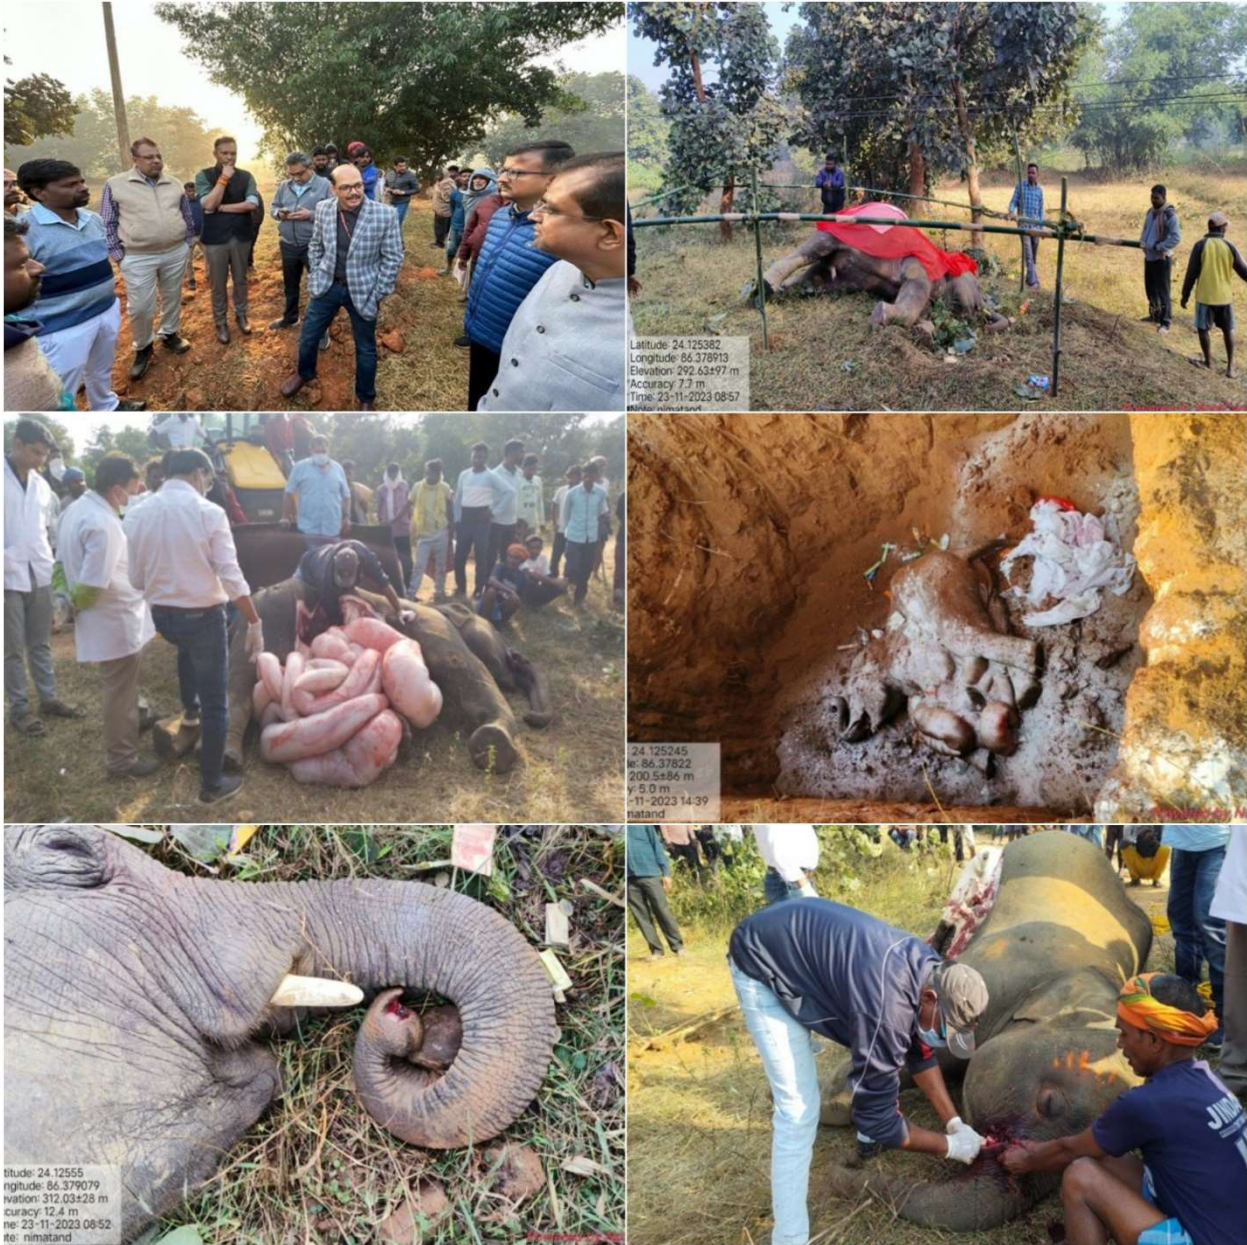
Photographs of Incident -4

<p>Details of the incident as recorded by the Forest Department:</p> <ul style="list-style-type: none"> • On 23/11/2023, a large herd of elephants was using the scrub forests near village Chitarpur (Tola - Nimatand) of Fulchi Panchayat in the Giridih district • A young male elephant (tusker) came into contact with a low-hanging 11 KV transmission wire and was electrocuted • The transmission line was sagging at around 6'6"
<p>Action taken by Forest Department:</p> <ol style="list-style-type: none"> 1. Forest Department engaged a team of veterinary doctors to conduct the postmortem on 23/11/2023 2. The Offence Report No. 001664 dated 23/11/2023 was registered by the Forest Department against Electrical Executive Engineer, Giridih Electrical Junior Engineer, Giridih, Electrical Assistant Engineer, Giridih and Electrical Line Man, All from Electrical Supply Division South Office, Giridih.
<p>Action taken by Power Department:</p> <ol style="list-style-type: none"> 1. Following the electrocution incident, the Power Department erected a pole in between two existing poles to reduce sagging. 2. Repair of sagging wires has been taken up at the site of electrocution.

<p>Observations and deliberations by the committee:</p> <ul style="list-style-type: none"> • The villagers of Chitarpur reported that the transmission wires in the area were sagging precariously low in numerous locations threatening both human and animal lives. They mentioned that numerous village livestock in the past were also electrocuted. The villagers further mentioned that the issue was taken up with the power supply officials, but were not resolved • The pictures of the deceased elephant taken before the postmortem were also examined(Enclosure - V) • During the time of Committee's visit, it was noticed that the wires were sagging in other locations too and the some of the poles were slanting.

On 23.11.2023 Electricution leading to death of one elephant at Chitarpur village (Tola-Nimatand), Fulchi Gram Panchayat, Giridih District, Khurchutta Forest Range, Giridihi East Forest Division.
